# Manhole Inspection Summary

Manhole # S49II\_035MH

Insp Date: **5/14/08 10:55 AM**

**Location** Address: **Luzerne**

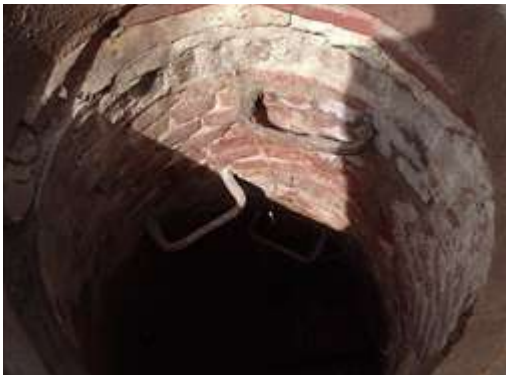
Defect 1

Infiltration: ☐ None ☒ **Joint** ☐ Cracks ☒ **Mortar** ☐ Roots ☐ Wall

Infiltration: ☐ None ☐ Joint ☐ Cracks ☐ Mortar ☐ Roots ☒ **Wall**

Infiltration

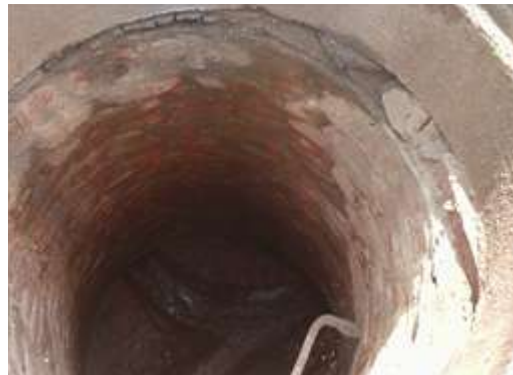
Defect 2

Condition: ☐ Sound ☐ Cracked ☐ Root Intrusion ☒ **Loose Brick** ☐ Deteriorated

loose bricks

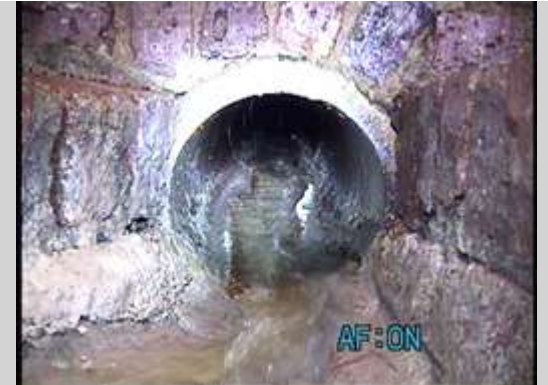
12 O'Clock Outflow

8 in. Circular Gravity Sewer  
Pipe Out @ 12 O'Clock

Pipe Height: **8.4** (in.) Rod and Bar (Angled)  
Pipe Material: **Clay** ☐ Pipe Lined  
Invert Depth: **9.65** (ft.) Flow Characteristics: **Fast**  
Deposits: ☒ None ☐ Mud ☐ Sludge ☐ Debris ☐ Grease  
Silt Depth: (in.) Deposits Extent:  
Infiltration: **None** Pipe Seal Cond: **Sound**

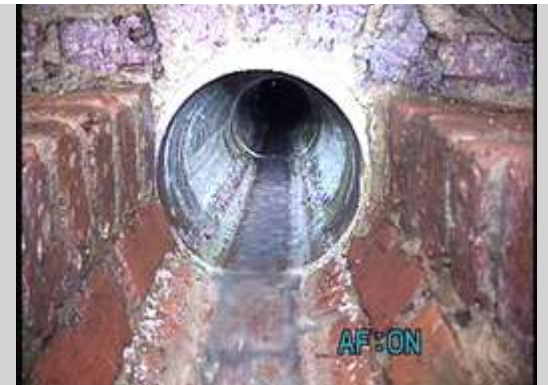
6 O'Clock Inflow

8 in. Circular Gravity Sewer  
Pipe In @ 6 O'Clock

Pipe Height: **8.4** (in.) Rod and Bar (Angled)  
Pipe Material: **Clay** ☐ Pipe Lined  
Invert Depth: **9.15** (ft.) Flow Characteristics: **Fast**  
Deposits: ☒ None ☐ Mud ☐ Sludge ☐ Debris ☐ Grease  
Silt Depth: (in.) Deposits Extent:  
Infiltration: **None** Pipe Seal Cond: **Sound**

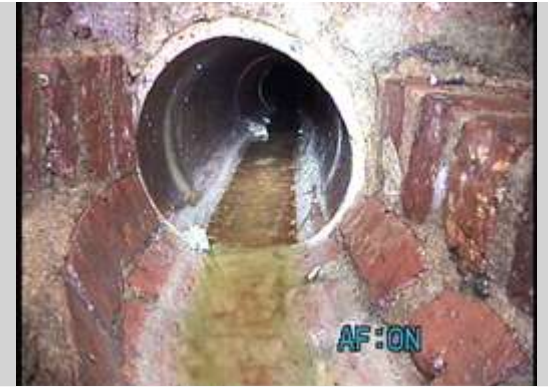
9 O'Clock Inflow

8 in. Circular Gravity Sewer

Pipe In @ 9 O'Clock

Pipe Height: **8.4** (in.) Rod and Bar (Angled)

Infiltration: **None** Pipe Seal Cond: **Sound**
